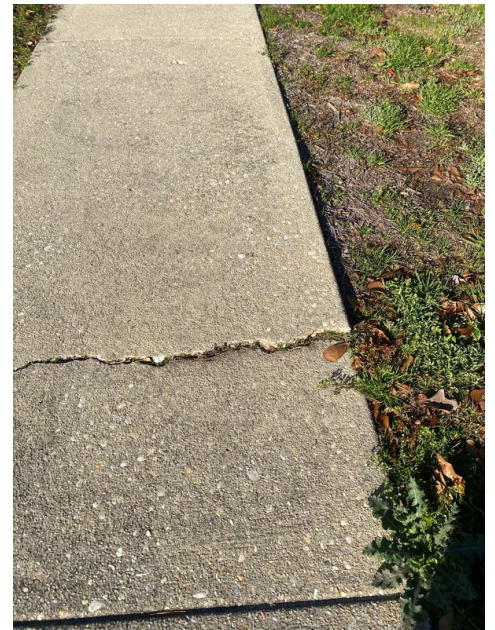
3.2.1 Driveway and Walkway Condition

TRIP HAZARD(S) PRESENT

Marginal Defect

SFTY - Cracking, heaving, settlement, movement, deterioration, and/or other deficiencies resulting in trip hazards were present on the referenced surface(s). Repairs are recommended to be conducted to these area(s) as needed for safety by a qualified contractor.

Contact a qualified professional.

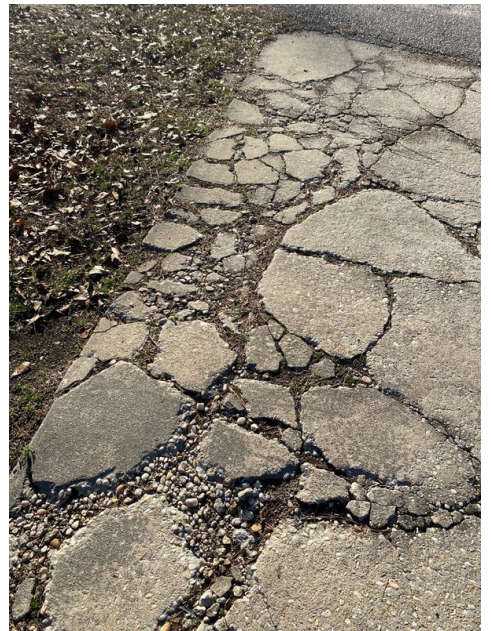
3.2.2 Driveway and Walkway Condition

CONCRETE - SPALLING (HEAVY DAMAGE)

— Marginal Defect

Heavy spalling damage was present on portions of the concrete surface. Repairs or replacement to the concrete as needed is recommended to be performed by a concrete contractor.

Contact a qualified concrete contractor.

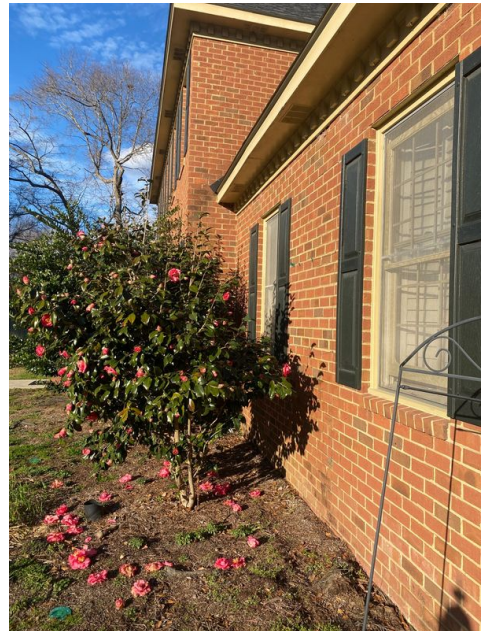
3.4.1 Vegetation Observations

— Minor Defect, Maintenance Item, or FYI Item

VEGETATION - AGAINST/NEAR THE HOME

There was vegetation in contact with, or in close proximity to the home in areas. Pruning or removal of any plants within 1-2 feet of the home is recommended to be conducted by a qualified person to eliminate pathways of wood-destroying insects and allow moisture to adequately dry behind these areas after rainfall events.

Contact a qualified landscaping contractor

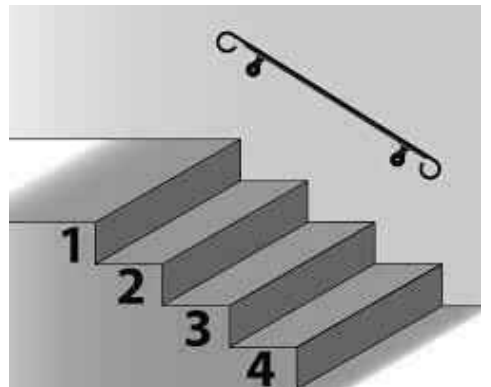
3.8.1 Guardrails, Stair Rails, & Handrails

HANDRAIL - NOT PRESENT 4 OR MORE RISERS

— Marginal Defect

SFTY - A handrail was not present for the stairs. Stairs four or more risers in height are recommended to have a handrail installed on at least one side for safety. The installation of a proper handrail is recommended to be conducted by a qualified person for safety.

Contact a qualified professional.
