RESIDENTIAL PROPERTY INSPECTION

1234 Main Street
Florence, SC 29505

Buyer Name
02/02/2023 9:00AM

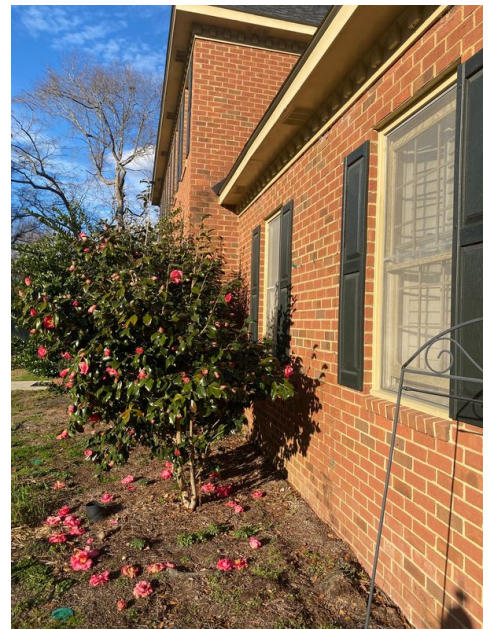
3.4.1 Vegetation

Observations

Contact a qualified landscaping contractor

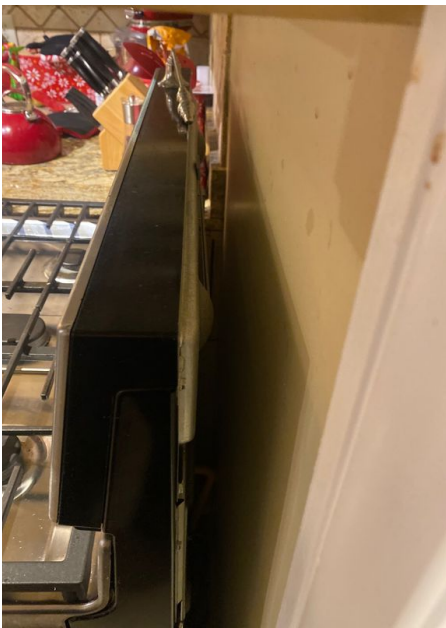
EXCL - The unit was not tested for the presence of an anti-tip bracket due to personal belongings being present on the range. The oven has to be "tipped" to test for this bracket and doing so would have caused the personal belongings to fall. The presence or absence of an anti-tip bracket is excluded from this inspection.
