RESIDENTIAL PROPERTY INSPECTION

1234 Main Street
Florence, SC 29505

Buyer Name
02/02/2023 9:00AM

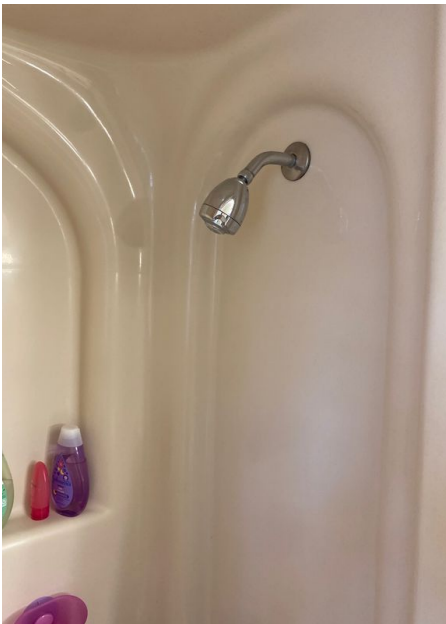
Upstairs hall shower

The shower(s) were inspected by operating the water valve(s) and ensuring proper flow and drainage was present, looking for leaks, and/or any significant defects. No reportable conditions were present at the time of inspection unless otherwise noted in this report.

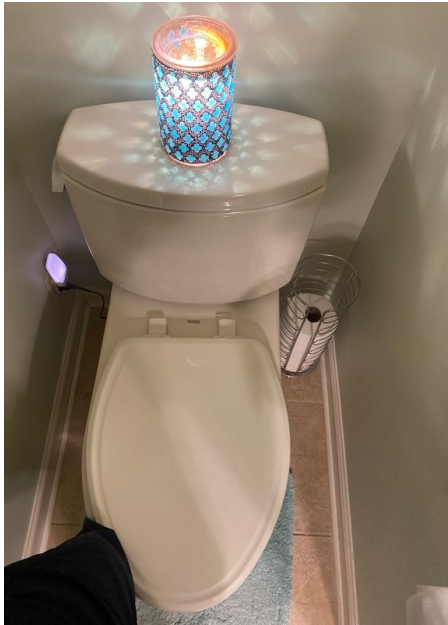
Master Bathroom

LMT - The toilets were inspected by flushing them to ensure they were flushing adequately and to determine that no leaks were present at the water supply line or tank location. No deficiencies were observed at the time of inspection unless otherwise noted in this report. Toilets are not tested for their attachment to the closet flange/anchor bolts as pushing on or manipulating a toilet can "break" the wax seal allowing for leaks. The securement of the toilets is excluded from this inspection.

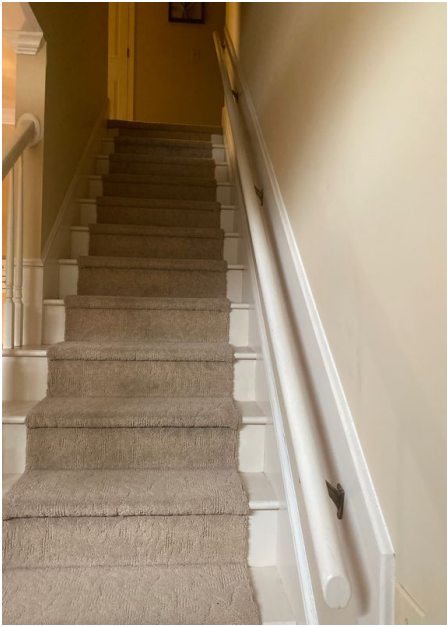
Front stairway

The stairs were inspected by evaluating the risers and treads, applicable railings, etc. No significant deficiencies were present at the time of inspection unless otherwise noted in this report.

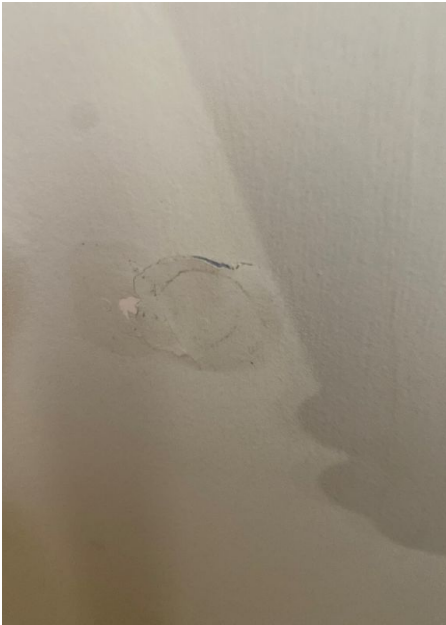
EXCL - Cosmetic deficiencies were present to wall, floor, and/or ceiling surfaces and are typically not reported on. If these cosmetic deficiencies are a concern, an evaluation and repairs as needed should be conducted by qualified tradespeople.

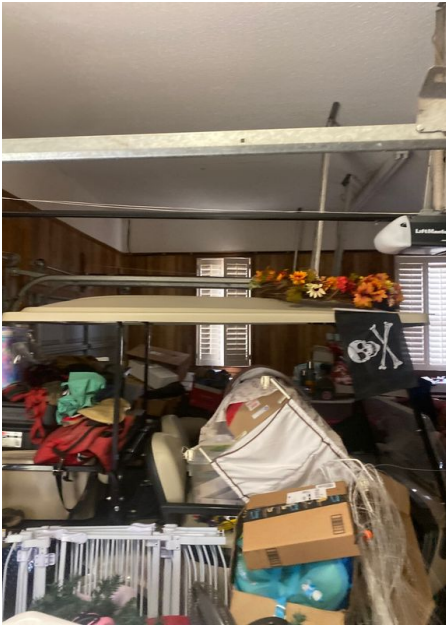
LMT - A heavy amount of personal belongings and storage was present in the garage. These items covered the majority of the walls and concrete slab floor surface. The condition of these items are excluded from this inspection. I highly recommend taking a final walk through of the home once vacant, to observe any areas that were not accessible during the inspection.

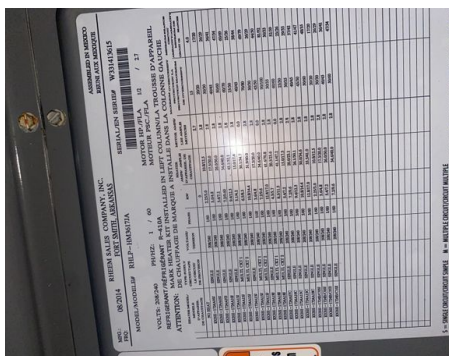
Interior Unit(s) - Split System : Interior Units Manufacture Year
2014

The typical life expectancy of electric units is approximately 13-15 years, and 15-17 years for gas units.

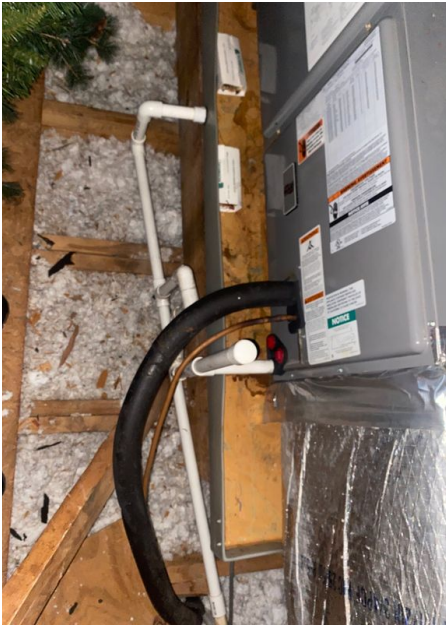
Auxiliary Drain Pan: Auxiliary Drain Pan - Drain Pipe

An auxiliary drain pan was present that had a drain pipe that was plumbed to the exterior. No deficiencies were observed unless otherwise noted in this report.

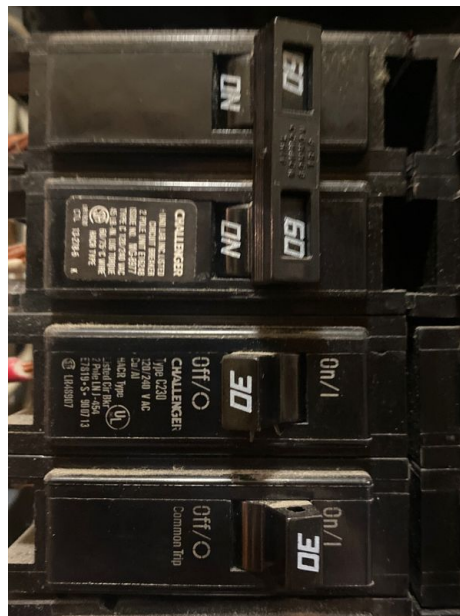
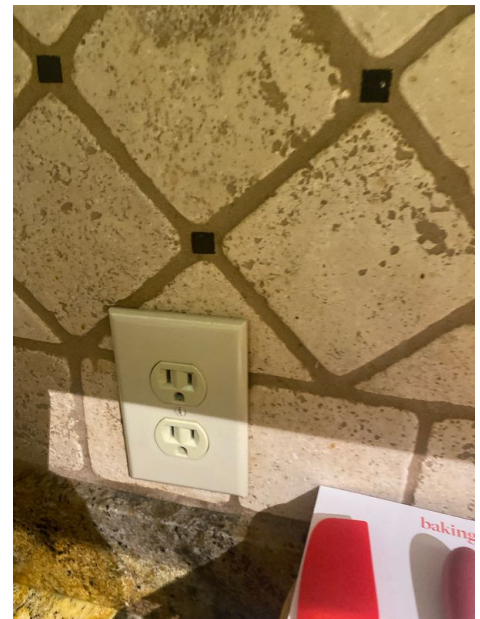
GFCI Protection: GFCI Missing/Damaged - Installation/Repairs Recommended
Kitchen

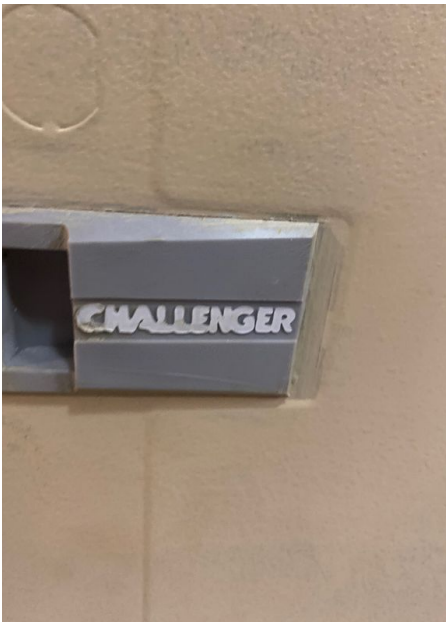
Challenger

No defects are found at time of inspection. There is a safety recall on this challenger panel.

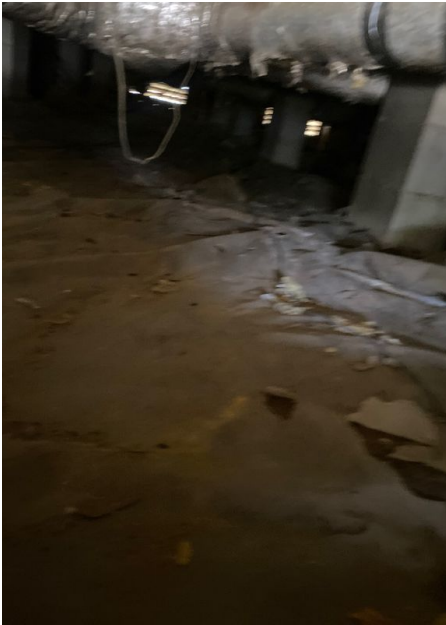
Ground Cover/Vapor Barrier : Vapor Barrier Information

Vapor barriers also called ground covers (if present) are inspected to ensure they cover the entirety of the soil in the crawl space, that they are not damaged or dry rotted, and contain no gaps. No reportable conditions were observed at the time of inspection unless otherwise noted in this report.

There were gaps present in the vapor barrier. Full coverage of the vapor barrier, eliminating any visible dirt, is recommended to minimize moisture, humidity, and possible condensation in the crawl space. Repairs to the vapor barrier are recommended as needed for full coverage by a qualified person.

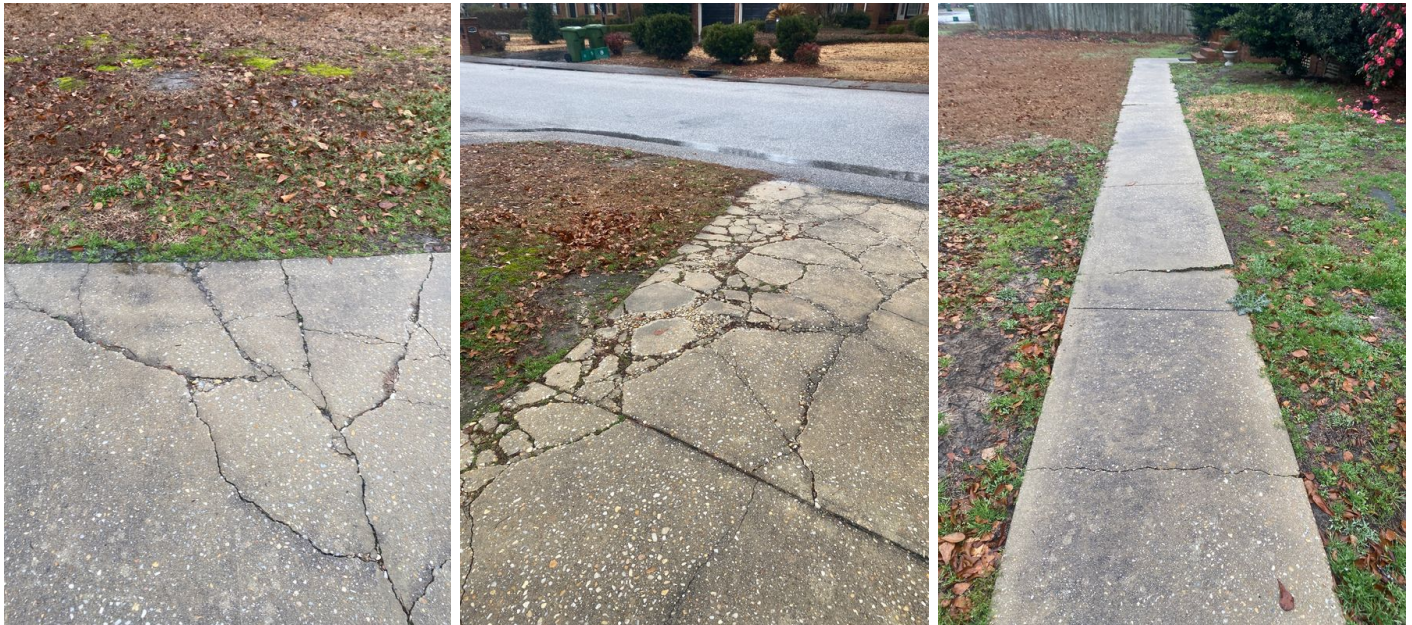
Exterior Hardscapes & Flatwork - CSM: Hardscape/Flatwork Cracking Information

LMT - Exterior hardscapes and flatwork were inspected for cracking and indications of movement and settlement. The acceptability of any cracking is dependent upon the client and is beyond the scope of a home inspection. Cracks will be reported as being minor, moderate, or significant in nature as they appeared on the day of the inspection and associated repairs are the decision of the client. Cracking to any degree is the result of some underlying condition which can include but is not limited to: improper preparation of the slab's support (soil, aggregate, foundation), improper concrete mixtures, undermining/erosion of the soil supporting the slab, the lack of relief, control, and/or expansion joints, etc. Lastly cracking can continue to worsen if left unrepaired and for this reason alone, evaluation and repairs to any cracking mentioned in this report is recommended to be performed by a qualified contractor.

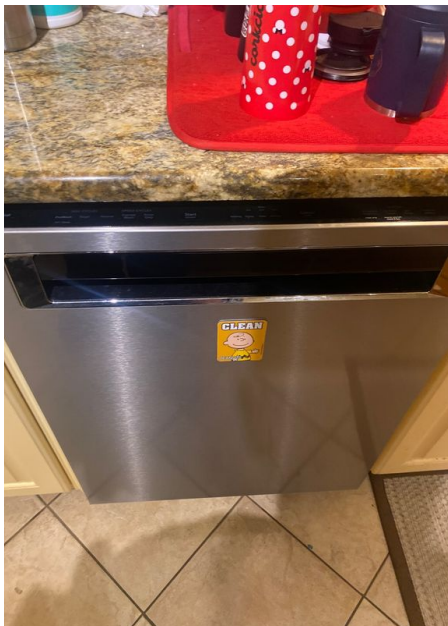
Dishwasher: Dishwasher Final Check

The dishwasher was turned off upon leaving, and the floor preceding it was checked to ensure no leaking was present.
